*Research Article*

## CYCLE TESTS AND STRUCTURE REPAIR OF BRIDGE PIER MODELS

**Innino Justitiannisa<sup>1\*)</sup> and Riawan Gunadi<sup>1)</sup>**<sup>1)</sup>Department of Civil Engineering, Politeknik Negeri Bandung, Bandung, Indonesia

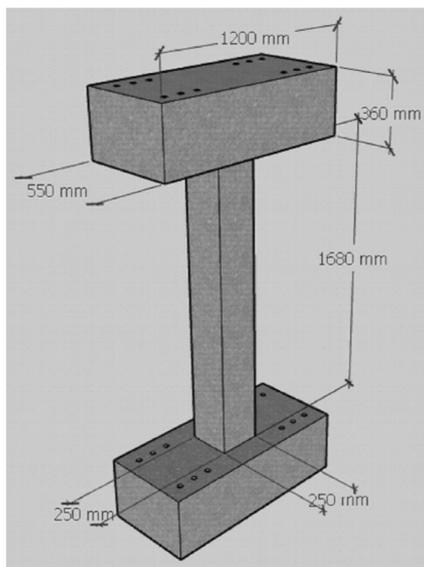
This research was conducted on one test object which is a bridge pier model. The pier model uses polymer concrete with a mixture of Styrene-Butadiene Rubber (SBR) materials. The pier model consists of 2 parts in the form of a column with dimensions of 0.25x0.25x1.68 meters and a stamp

column of 1.20x0.55x0.36 meters. The test object specifications will use FC'30 concrete, which is the average compression of cylindrical concrete strength test at 28 days of age and  $f_y$  400 MPa deform reinforcement. The results of the reinforcement tensile test are shown in Table 1. Figure 1 shows the specifications of the pier model as follows.

Figure 1. Pier model specifications

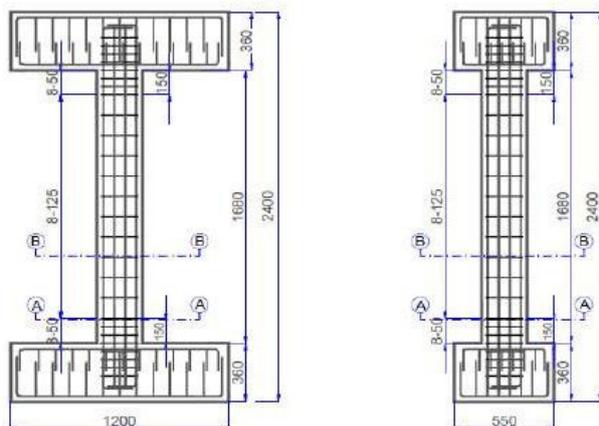
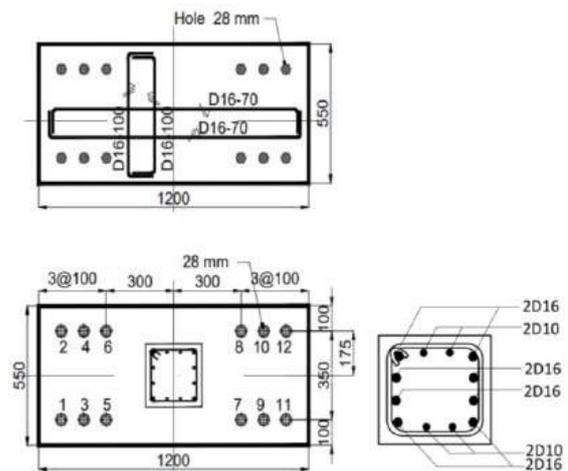
The pier model uses longitudinal reinforcement 8D16 and 4D10. The stirrup used with a diameter of Ø8-75 mm and Ø8-125 mm, as indicated in Figure 2. On the bridge pier model, two strain gauges are installed in one direction for lateral loading. Strain gauge instrument installation in the bridge pier model can be seen in Figure 3.

Figure 2. Reinforcement details of the bridge pier model

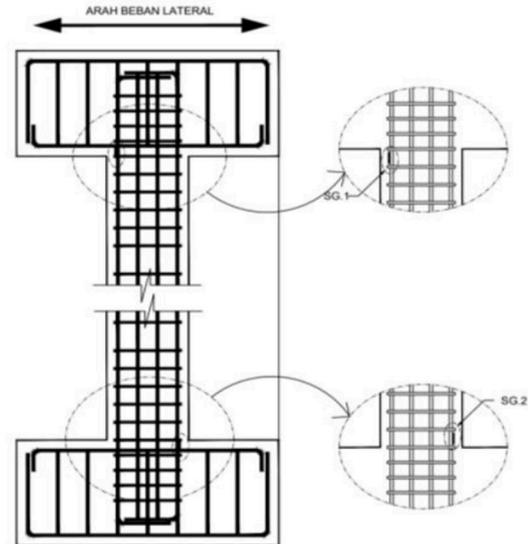
Figure 3. Strain gauge location on bridge pier model

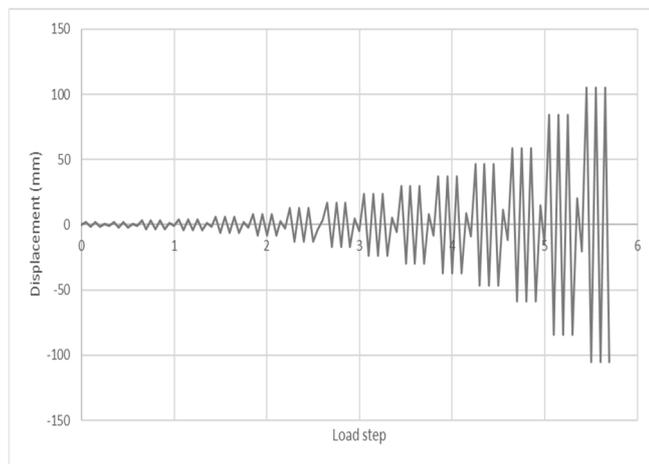
When the cyclic test is to be carried out, the pier model is mounted on the loading frame and then a Linear Variable Displacement is installed to identify damage at several points when a lateral load is applied to the pier model. This test provides a load in the form of alternating direction deviation. There are 3 cycles for each deviation with an increase in the given deviation 0.25 – 0.5 times greater than the previous deviation. The cyclic test is terminated when the specimen is at a load level of approximately 80% of the peak load. The loading pattern in this test can be seen in Figure 4 and in Figure 5 can be seen the tool settings, test illustrations, and LVDT locations during cyclic testing.

Figure 4. Lateral loading pattern

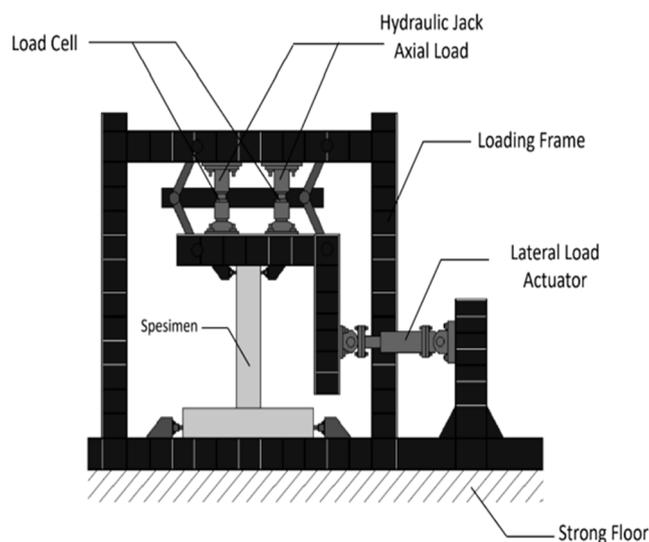
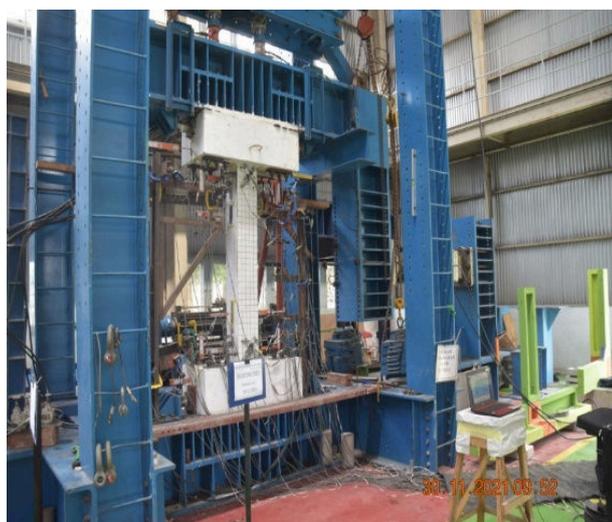
Figure 5. Pier model illustration

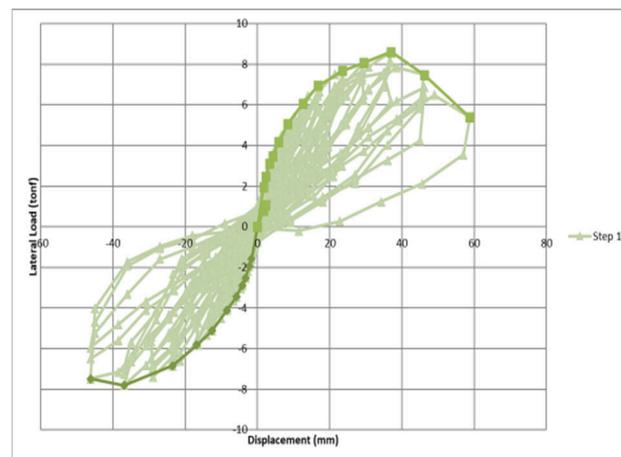
Figure 6. Hysteresis curves in the first step

Figure 6 shows in the first step that when the pier model is given a thrust load, the load increases significantly in line with the increase in displacement that occurs up to a drift ratio of 2.20%. After that, the curve decreased to a drift ratio of 3.50%, as was the case when a tensile load was applied.

The test results at step 1 and step 2 showed that the relationship between lateral load and displacement was displayed in the form of a hysteresis curve as shown in Figure 6 and Figure 7 below.

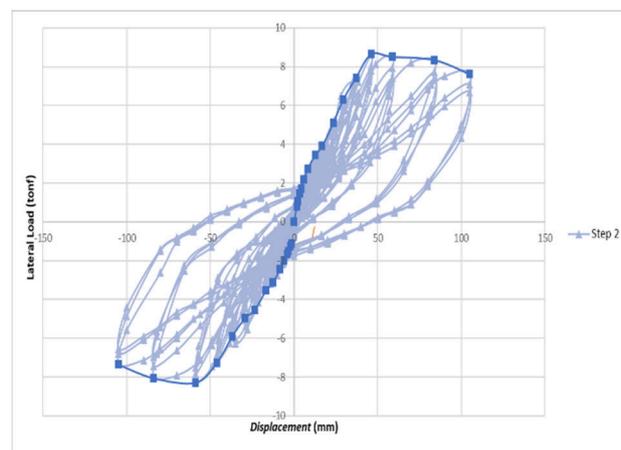
Figure 7. Hysteresis curves in the second step

Figure 7 shows the results of cyclic testing in step 2 where testing was carried out until the drift reached 6.25% for push and pull direction. The overall hysteresis curve obtained shows a good picture of behavior because there is no decrease in stiffness and significant strength during loading at any drift ratio. The second stage of testing experienced quite large and still displacement able to survive without causing further damage in several loading cycles.

Based on the backbone curve in Figure 7, it can be seen that the peak strength obtained in step 1 was 8,606 tonf in the pushing direction and 7,812 tonf in the pulling direction and the peak strength in step 2

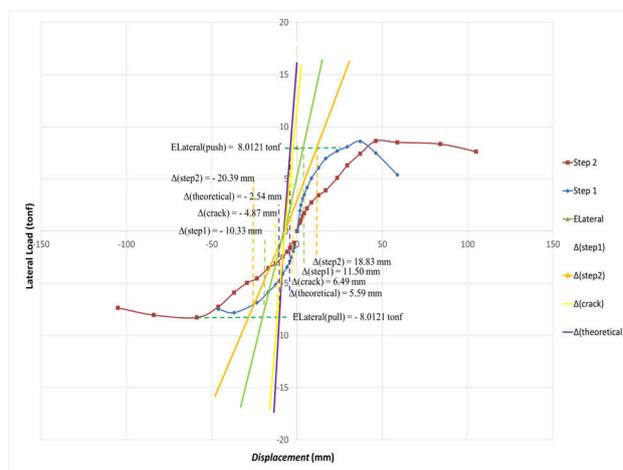
Analysis of the load-displacement relationship carried out theoretically with a given axial load of 30 tonf and a nominal moment of 66 kN.m produces a lateral load of 8.0121 tonf in the push and pull directions. The theoretical calculated lateral load is plotted on the spine curve which can be seen in Figure 8 so that the displacement in the intact (theoretical) condition is 5.59 mm in the pushing direction and -2.54 mm in the pulling direction. In cracked conditions, the displacement in the pushing direction shows a result of 6.42 mm and -4.87 mm in the pulling direction. while the experimental results in step 1 with a lateral load of 8.0121 tonf showed a displacement of 11.50 mm in the pushing direction and -10.33 in the pulling direction. The experimental results in step 2 with a lateral load of 8.0121 tonf showed a displacement of 18.83 mm in the pushing direction and -20.39 in the pulling direction. This shows that the displacement at the lateral load of 8.0121 tonf is greater than the results of the displacement when intact and cracked (theoretical). The results of theoretical and experimental calculations of the load - displacement relationship can be seen in Table 2.

Figure 8. Backbone Curve in the first and second steps

According to ACI 374.1-05, the deformation capacity can be calculated in conditions where the lateral load is stopped during softening conditions and should not be less than 75%  $E_{max}$  in the same load direction and the results of the analysis are presented in Figure 8 and Table 3.

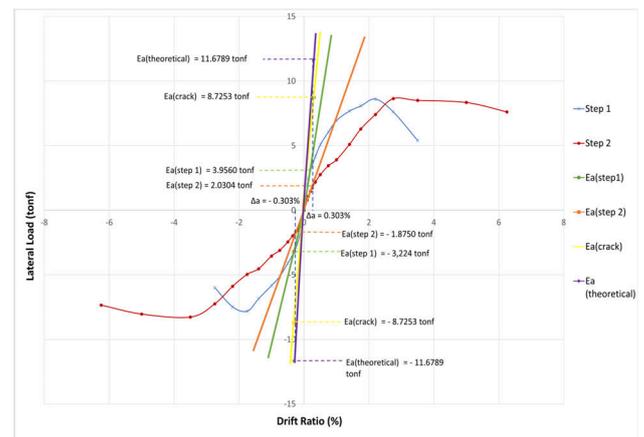
The initial stiffness is the ratio between the force and the displacement that occurs at the initial applied lateral load which can be described as the slope in the displacement interval of +0.35% to -0.35%. The test results on the pier model in the first step of the experiment had a lower initial stiffness compared to theoretical calculations both in intact condition and when cracked. Theoretical and experimental results can be seen in Table 3 and Figure 9.

Figure 9. Initial Stiffness in the first and second steps

The experimental results in step 1 show an initial stiffness of 0.7196 in the pushing direction and 0.5862 in the pulling direction. Meanwhile, experimental results in step 2 show an initial stiffness of 0.3693 in the pushing direction and 0.3408 in the pulling direction.

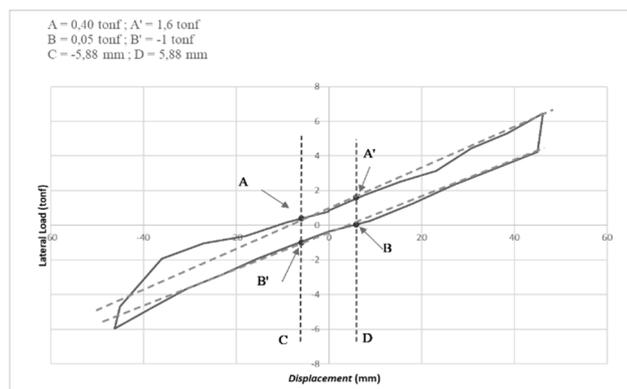
Stiffness degradation describes a decrease in structural stiffness during loading and reverses loading. Stiffness degradation is calculated according to ACI 374.1-05. Stiffness calculations in this study were analyzed at a drift ratio of 2.75% which was used as a tool for calculating stiffness. Stiffness degradation was calculated with reference to Figure 10, Figure 11 and Table 3.

Figure 10. Initial Stiffness in the first step

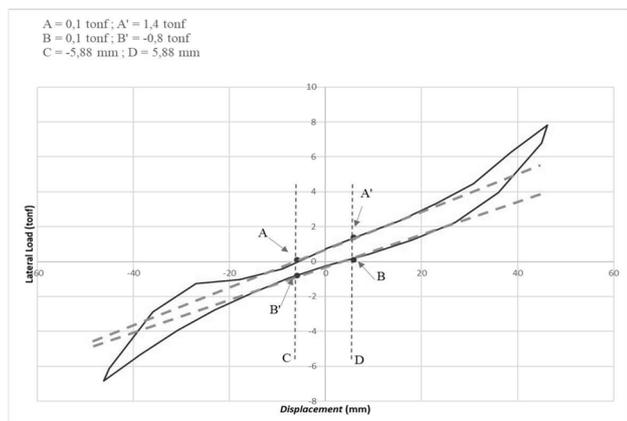
Figure 11. Initial Stiffness in the second step

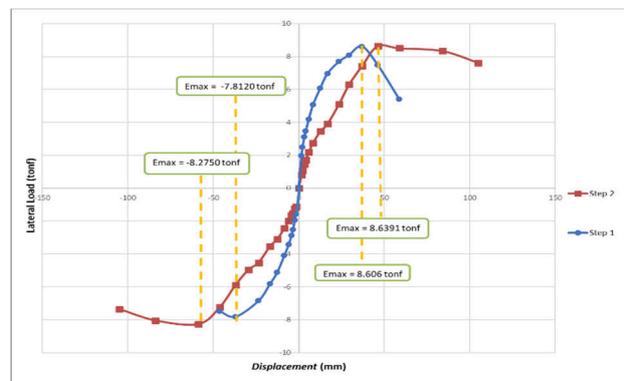
was 8,640 tonf in the pushing direction and 8,275 tonf in the the pulling direction. Meanwhile, the peak strength from theoretical calculation results shows a result of 15.21144 tonf in the push and pull directions. The theoretical peak load analysis is carried out by determining the strength.

Figure 12. Peak strength in the first and second steps

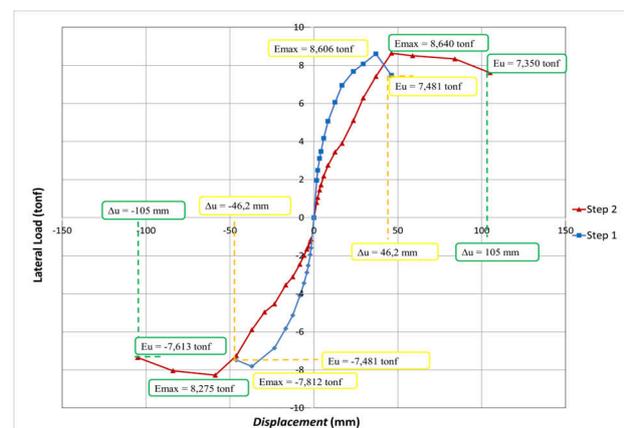
Figure 13. Deformation capacity in the first and second steps

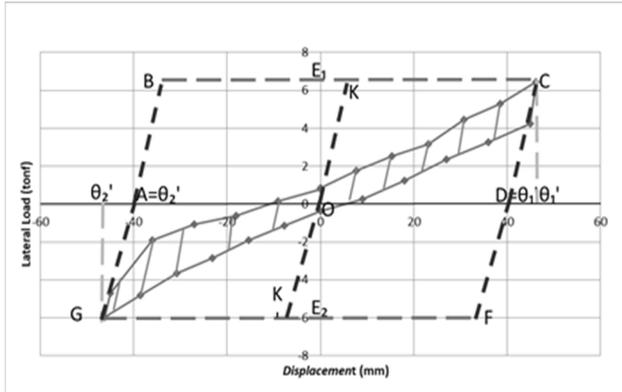
calculated based on the difference in magnitude the displacement that occurs is multiplied by its magnitude lateral load. The energy dissipation is described as the area of the parallelogram ABCD. The results of the energy dissipation calculation for the first step of testing are presented in Table 6, Figure 14, and Figure 15.

Figure 14. Energy dissipation in the first step

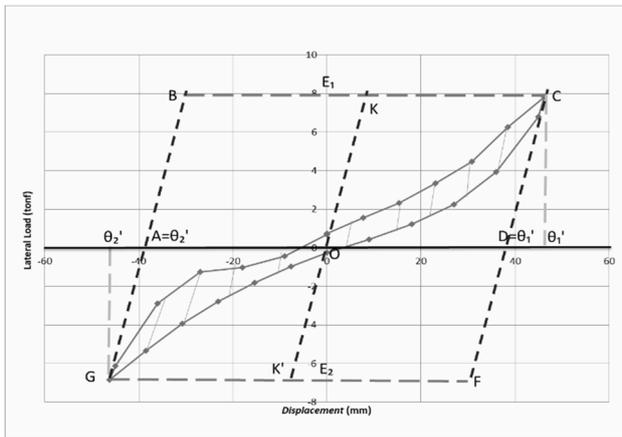
Figure 15. Energy dissipation in the second step

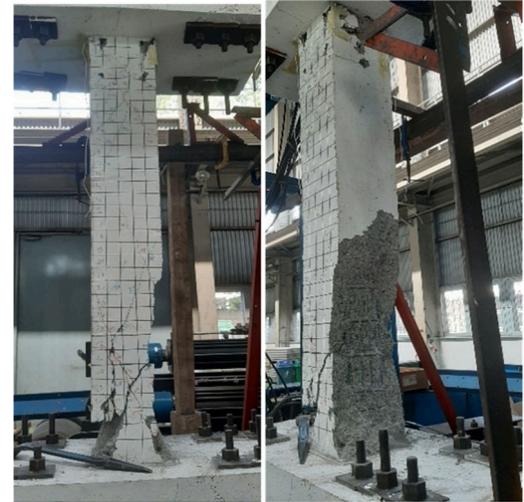
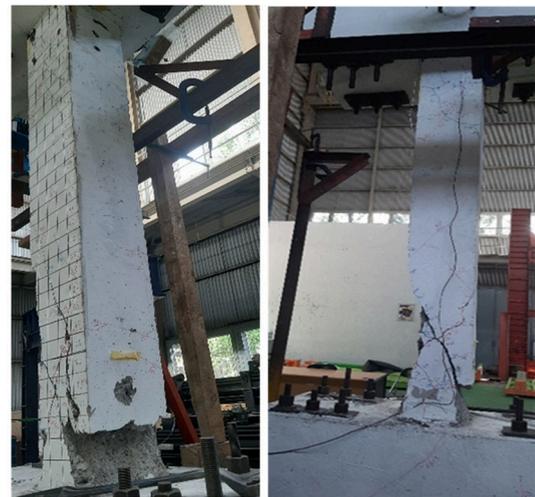
increases and approaches the maximum load, the cracks increase but are still very fine, but after the load reaches the maximum, the pier model collapse and the concrete cover begins to peel off (cover spalling). The damage that occurred in the first step can be seen in Figure 16.

In the first step, the lateral load of the pier model is relatively small so that cracks do not occur. However, when the lateral load increases, cracks begin to appear. The first cracks in the first step of testing occurred at a drift ratio of 0.20% with microcracks appearing at the upper and lower ends of the pier model. This crack is dominated by a shear crack that starts from the starboard surface and increases all over the side of the pier model. Cracks experience addition or widening. When the load

Figure 16. Damage pattern in the first step

The pier model suffered damage in step 1 which was dominated by shear cracks (diagonal/oblique cracks) which started from the edge of the pier and spread to all sides and along the height of the pier causing cracks in the pier which exceeded the thickness of the concrete layer. The crack pattern is cracked at the edge of the pier and spreads wider towards the middle of the span until cover spalling occurs. Repair with grouting and wrapping materials in step 2 is possible prevent the expansion of shear cracks due to previous loading and prevent the appearance of new shear cracks thereby forming a crack pattern development of flexural cracks with the resulting crack patterns after the bridge pier model was repaired.

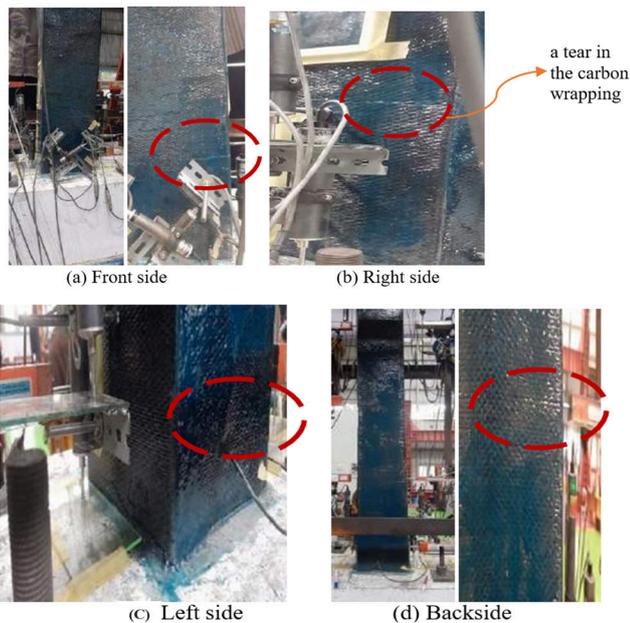
In the second step of testing the reinforcement has exceeded the yield so that the performance of the reinforcement in response to tension decreases and begins to be replaced by carbon wrap. From the results of observations of the second stage of testing, it shows A tear in the carbon wrap with a bending pattern (longitudinal direction) on the part bottom of the pier. The tear occurred first at a drift ratio of 1%. This shows that carbon wrap is starting to play a role so the shear capacity increases. The tear increases with the rise given load. Elongation or widening of the tear that occurs in the second test when the load increases close to the load maximum. When the maximum load is 8,640 tonf. Damage incurred the second step of testing was dominated by damage due to bending which can be seen in Figure 17.

Figure 17. Damage pattern in the second step

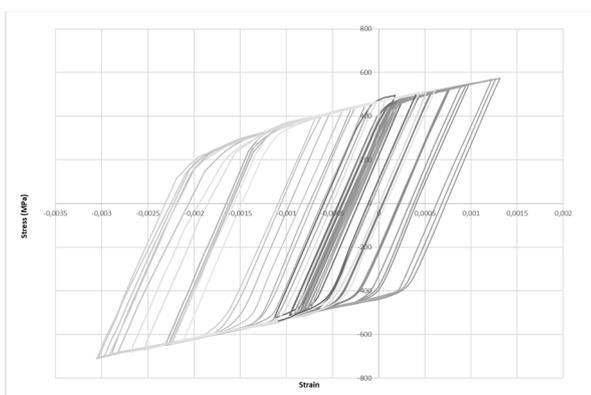
(a) Stress-strain reading (SGT-1) on first-step cyclic reinforcement

Figure 18. Cyclic stress-strain readings of reinforcement

Figure 18 shows the results of the stress-strain during the yield (elastic) condition at the start of loading which is read at SGT 1 in the push direction with stress of 545.939311 Mpa and a strain of 0.000180288 when the drift ratio is 0.10% with a lateral load of 1.95 tonf and the strain stress read by SGT 2 in the push direction with the stress of 542.3416327 Mpa and a strain of 0.000176998 when the drift ratio is 0.10% with a push lateral load of 1.557 tonf. The maximum strain obtained from the results of the first step of testing for the push direction in the drift direction is 0.50% and the pull direction is 1.75% which is read on SGT 1 and SGT 2. The maximum strain read by SGT in the push direction is 574.01736 MPa and strain of 0.001313 and the maximum stress in the pull direction of -711.0730 MPa and strain -0.003059. The results of SGT 2 show that the maximum stress in the push direction is 496.6689 MPa and the strain is -0.000424 and in the pull direction the stress is -595.9668 MPa and the strain is -0.0020180.

The results of the stress-strain in the first step of SGT 1 show that the maximum stress in the pushing direction is 574.01736 MPa and the strain is 0.001313 at a drift ratio of 0.50% and the maximum stress in the pulling direction is -711.0730 MPa and the strain is -0.003059 at a deviation ratio of 1.75%. The results of SGT 2 in the first step of testing showed that the maximum stress in the thrust direction was 496.6689 MPa and the strain was -

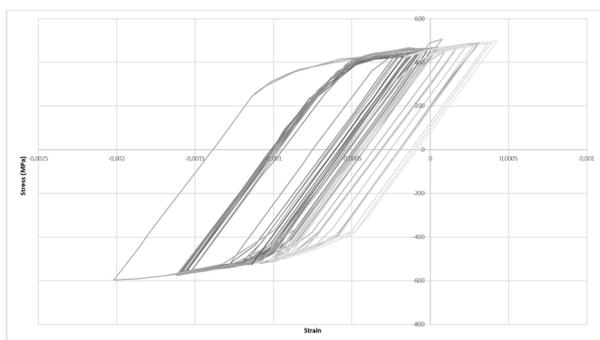
(b) Stress-strain reading (SGT-2) on first-step cyclic reinforcement

0.000424 at a drift ratio of 0.50%. and -595.9668 MPa at tensile stress and -0.0020180 at strain with a drift ratio of 1.75%. However, the reinforcement experienced the first yield at a drift ratio of 0.10% with a stress of 545.939311 Mpa and a strain of 0.000180288 which was read at SGT 1 and at SGT 2 it was read that the reinforcement had yielded at a drift of 0.10% with a stress of 542.3416327 Mpa and Strain 0.000176998.
